Paul's Picks #1:

Spontaneous Trenching Fire Sequence

June 2003

Warren C&D Landfill - Ohio

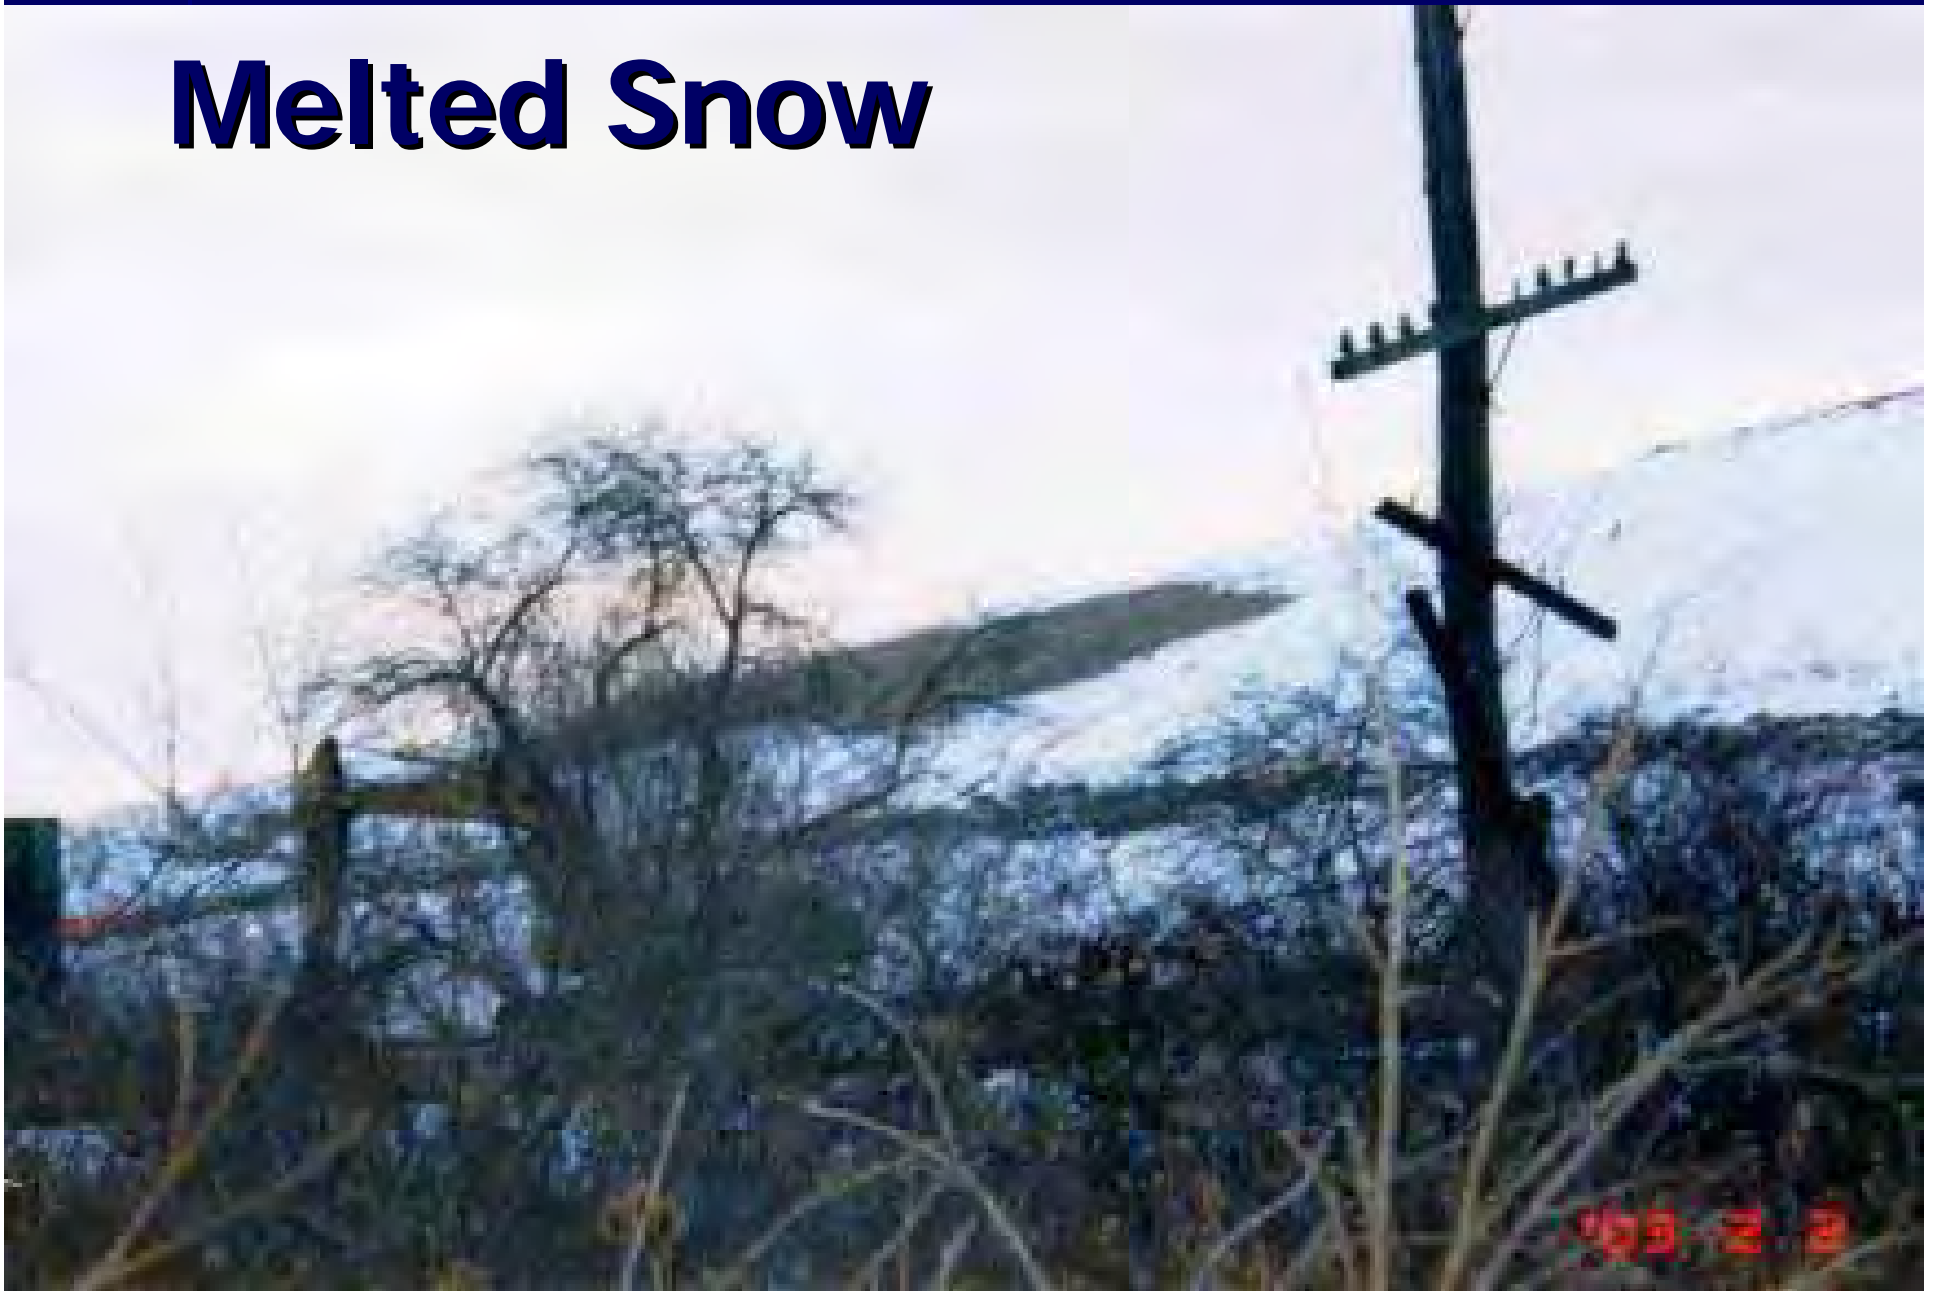
Subsurface Fire ?

- Culprit
 - Poor compaction
 - Decomposition
 - Leachate re-circulation
- Smoke visible along RR tracks
 - Bare spots in winter despite snow cover
 - Wisps of smoke (acrid, burning odor)

Melted Snow

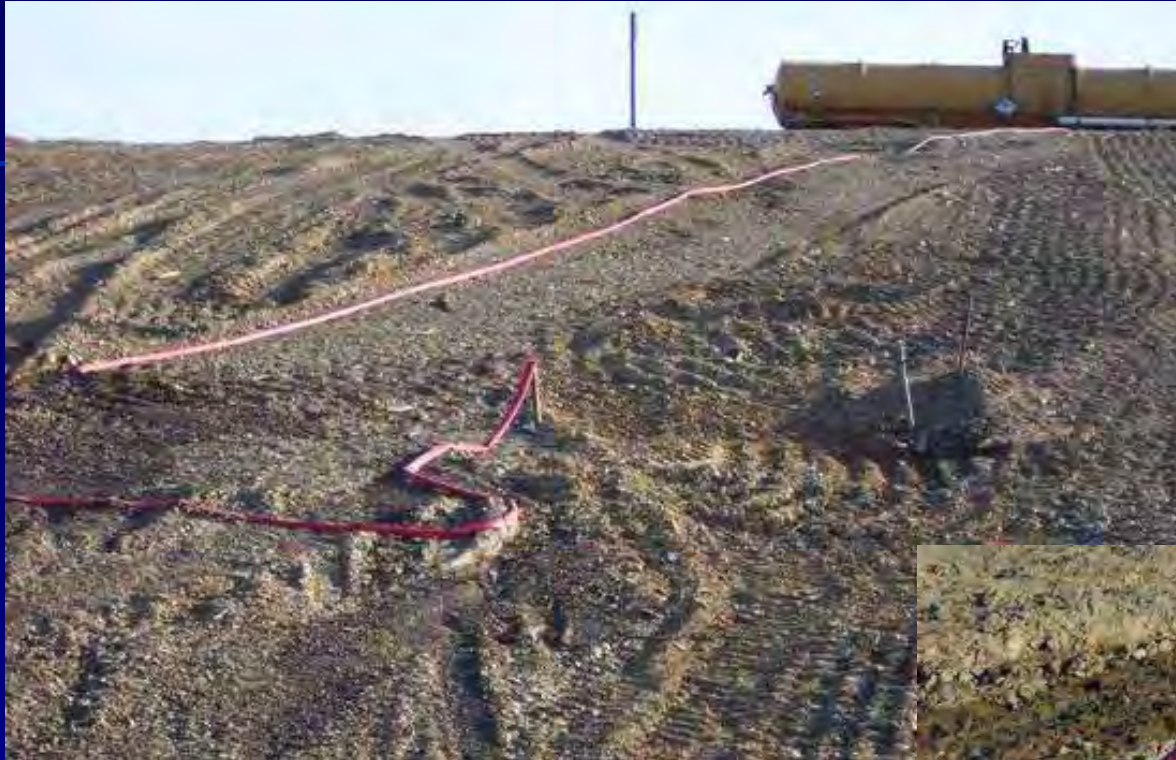
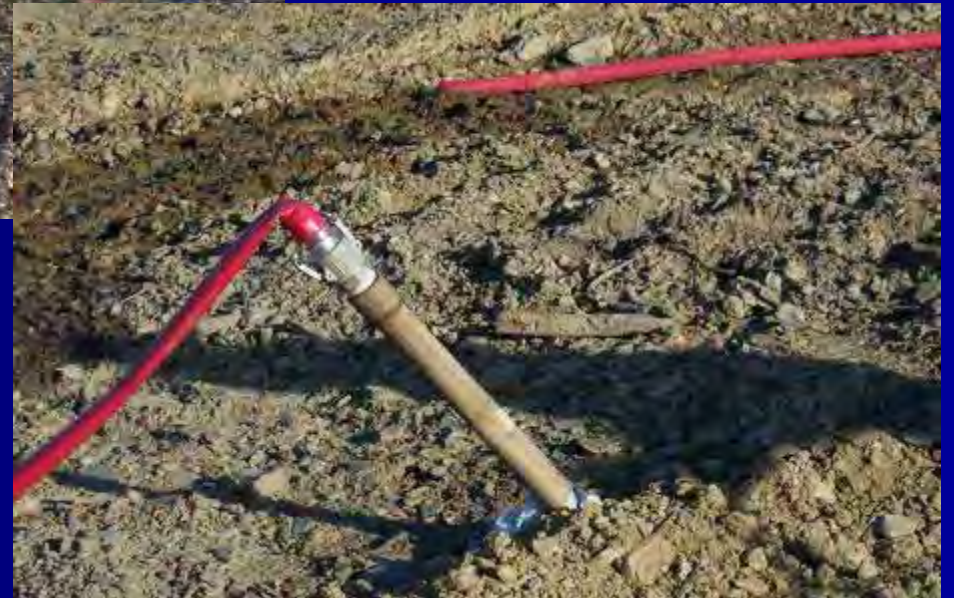
Pipes / Hoses

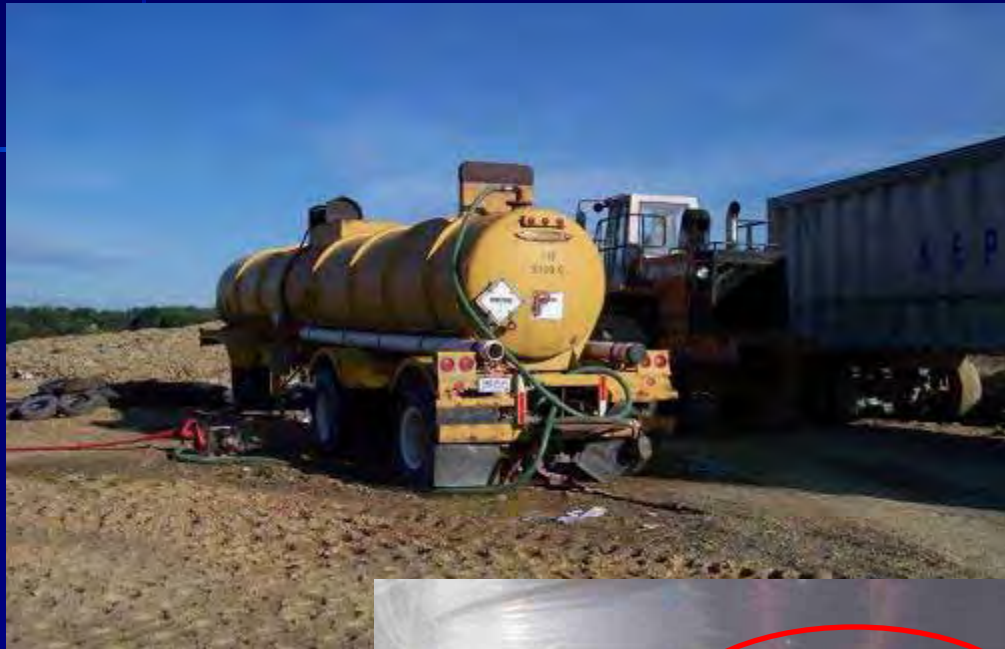
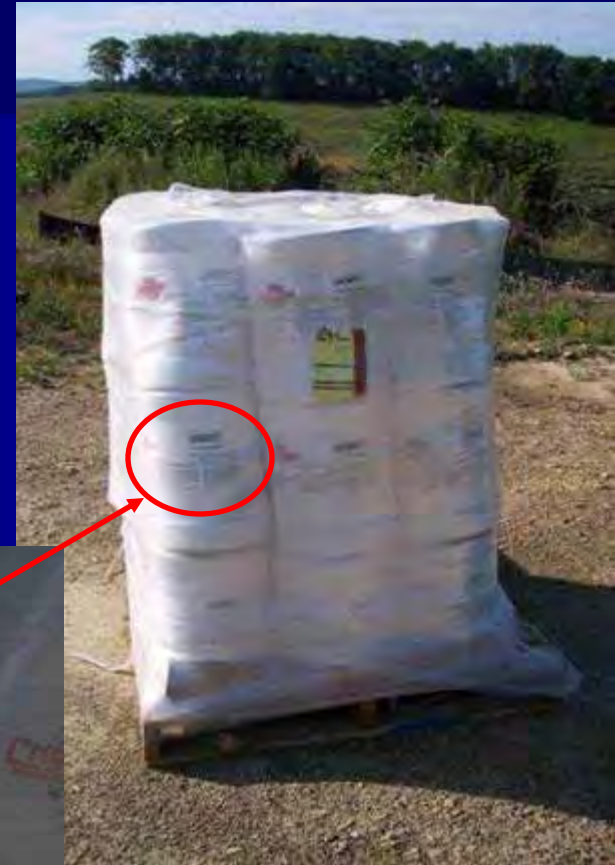
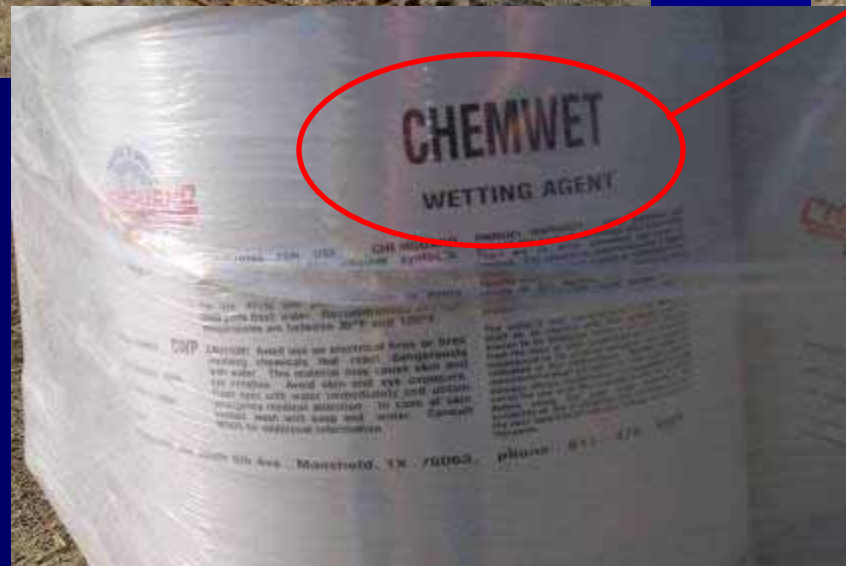
Tankers / Pallets

**Usually a surfactant
or wetting agent**

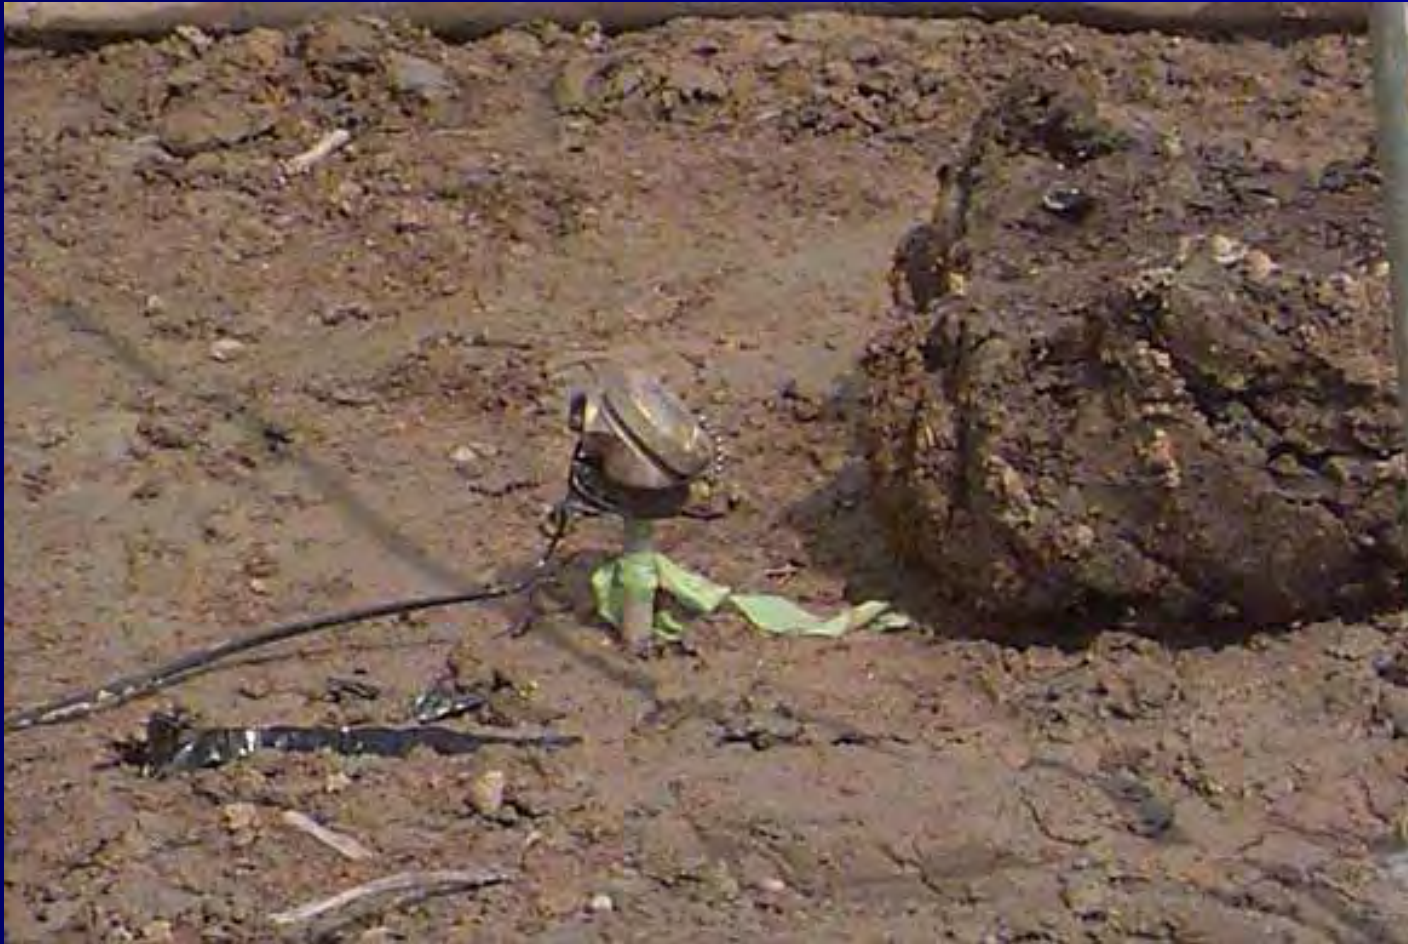
Temp Probes

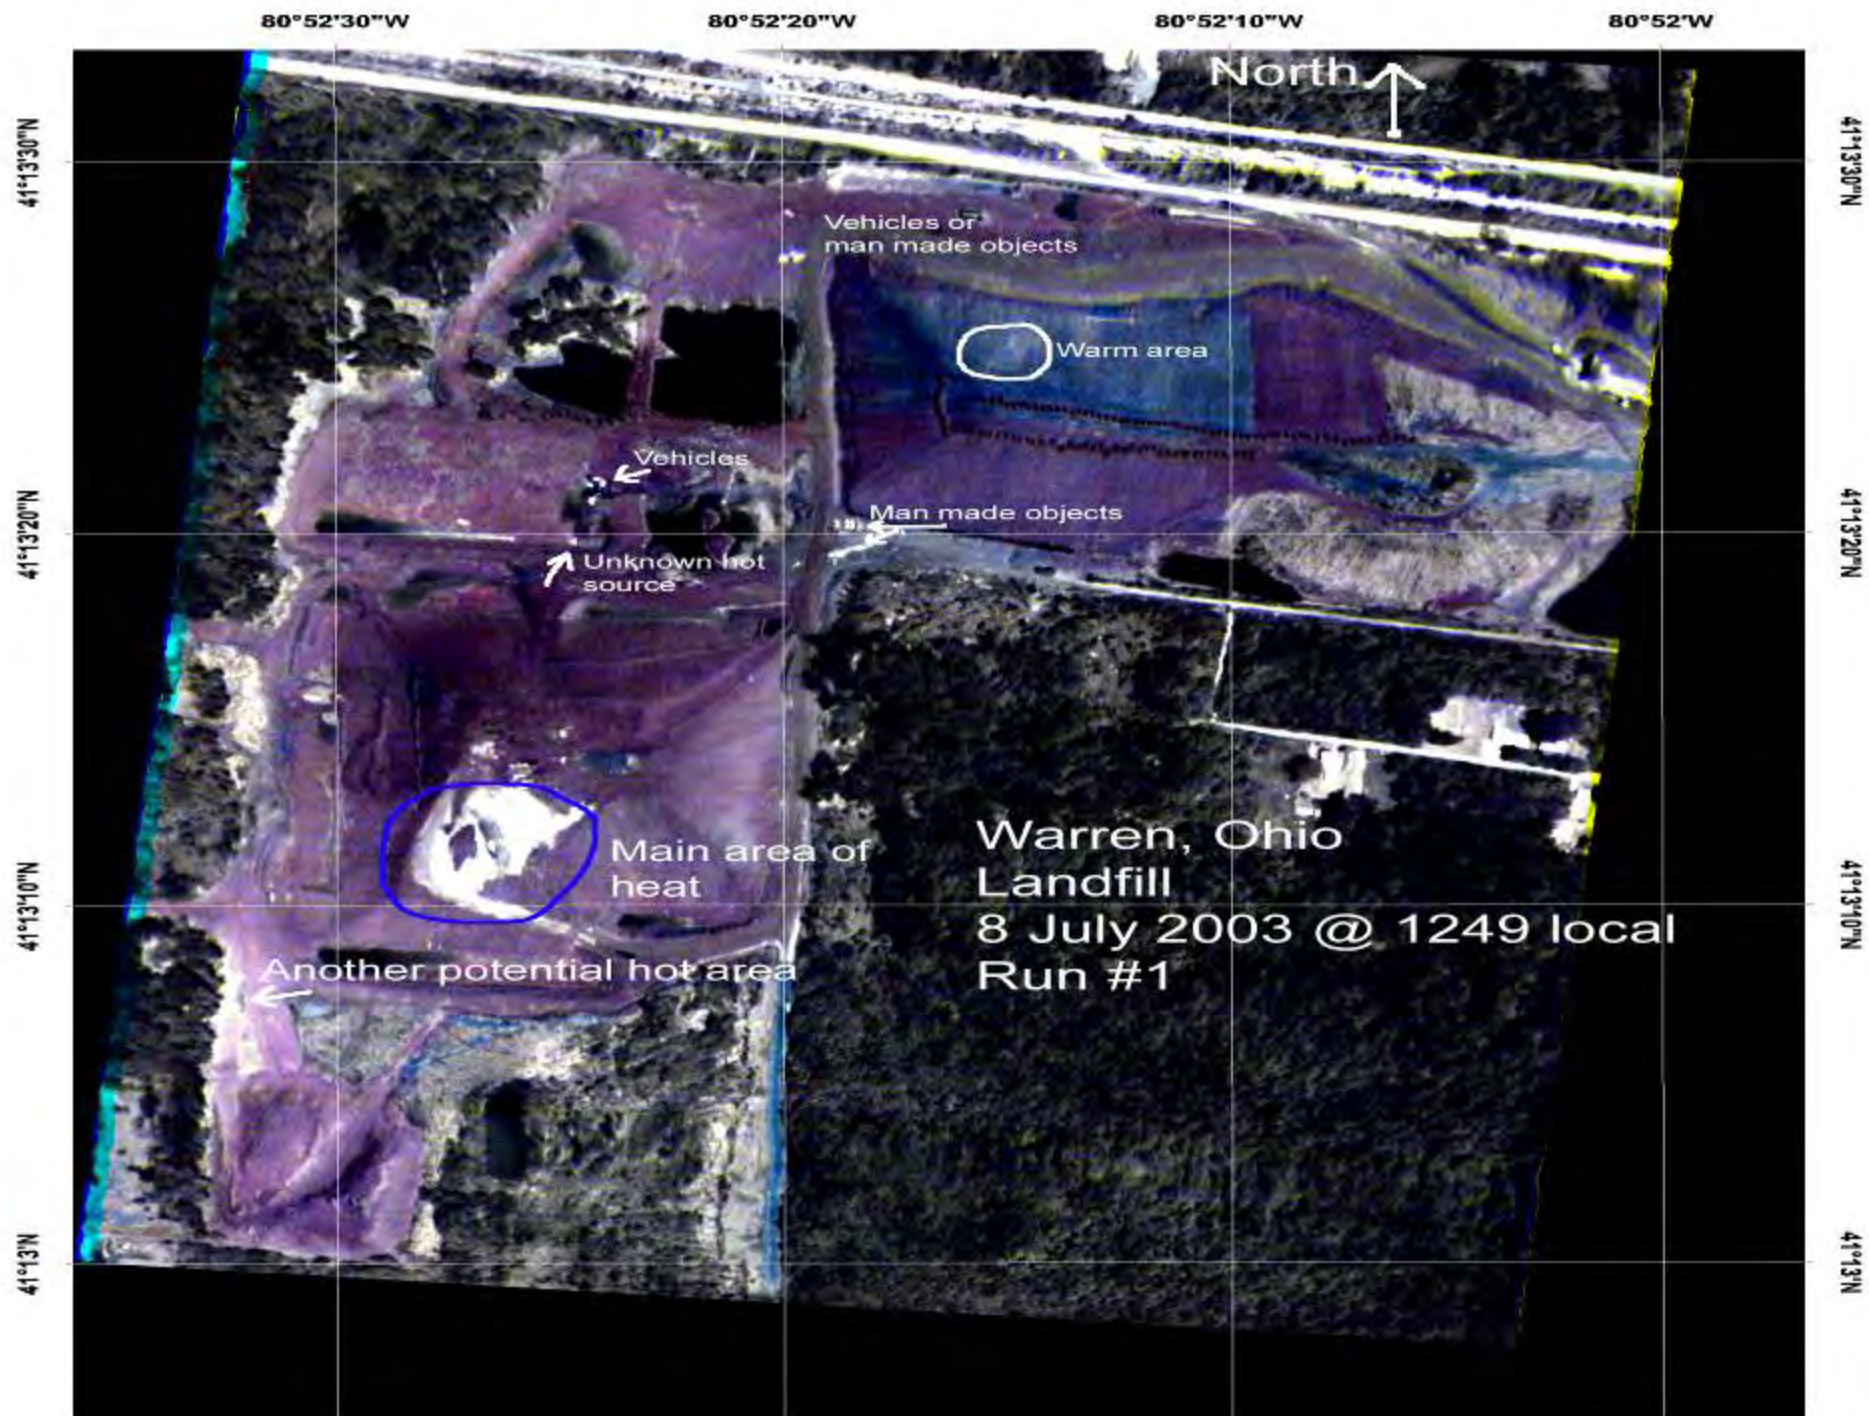
Aerial Thermograph

- EPA Contractor
 - 7 runs, 2200' elevation, 12:45 – 1:10pm
 - Olympus E20 digital camera
- Temperature & chemical analysis
 - RS-800 Infrared line scanner
 - MR245 FTIR hyper-spectral scanner
- Ambient temperatures on surface
 - Areas of concern
 - Pure white areas above 50°C or 120°F
 - Areas of interest
 - Areas above 28°C or 80°F

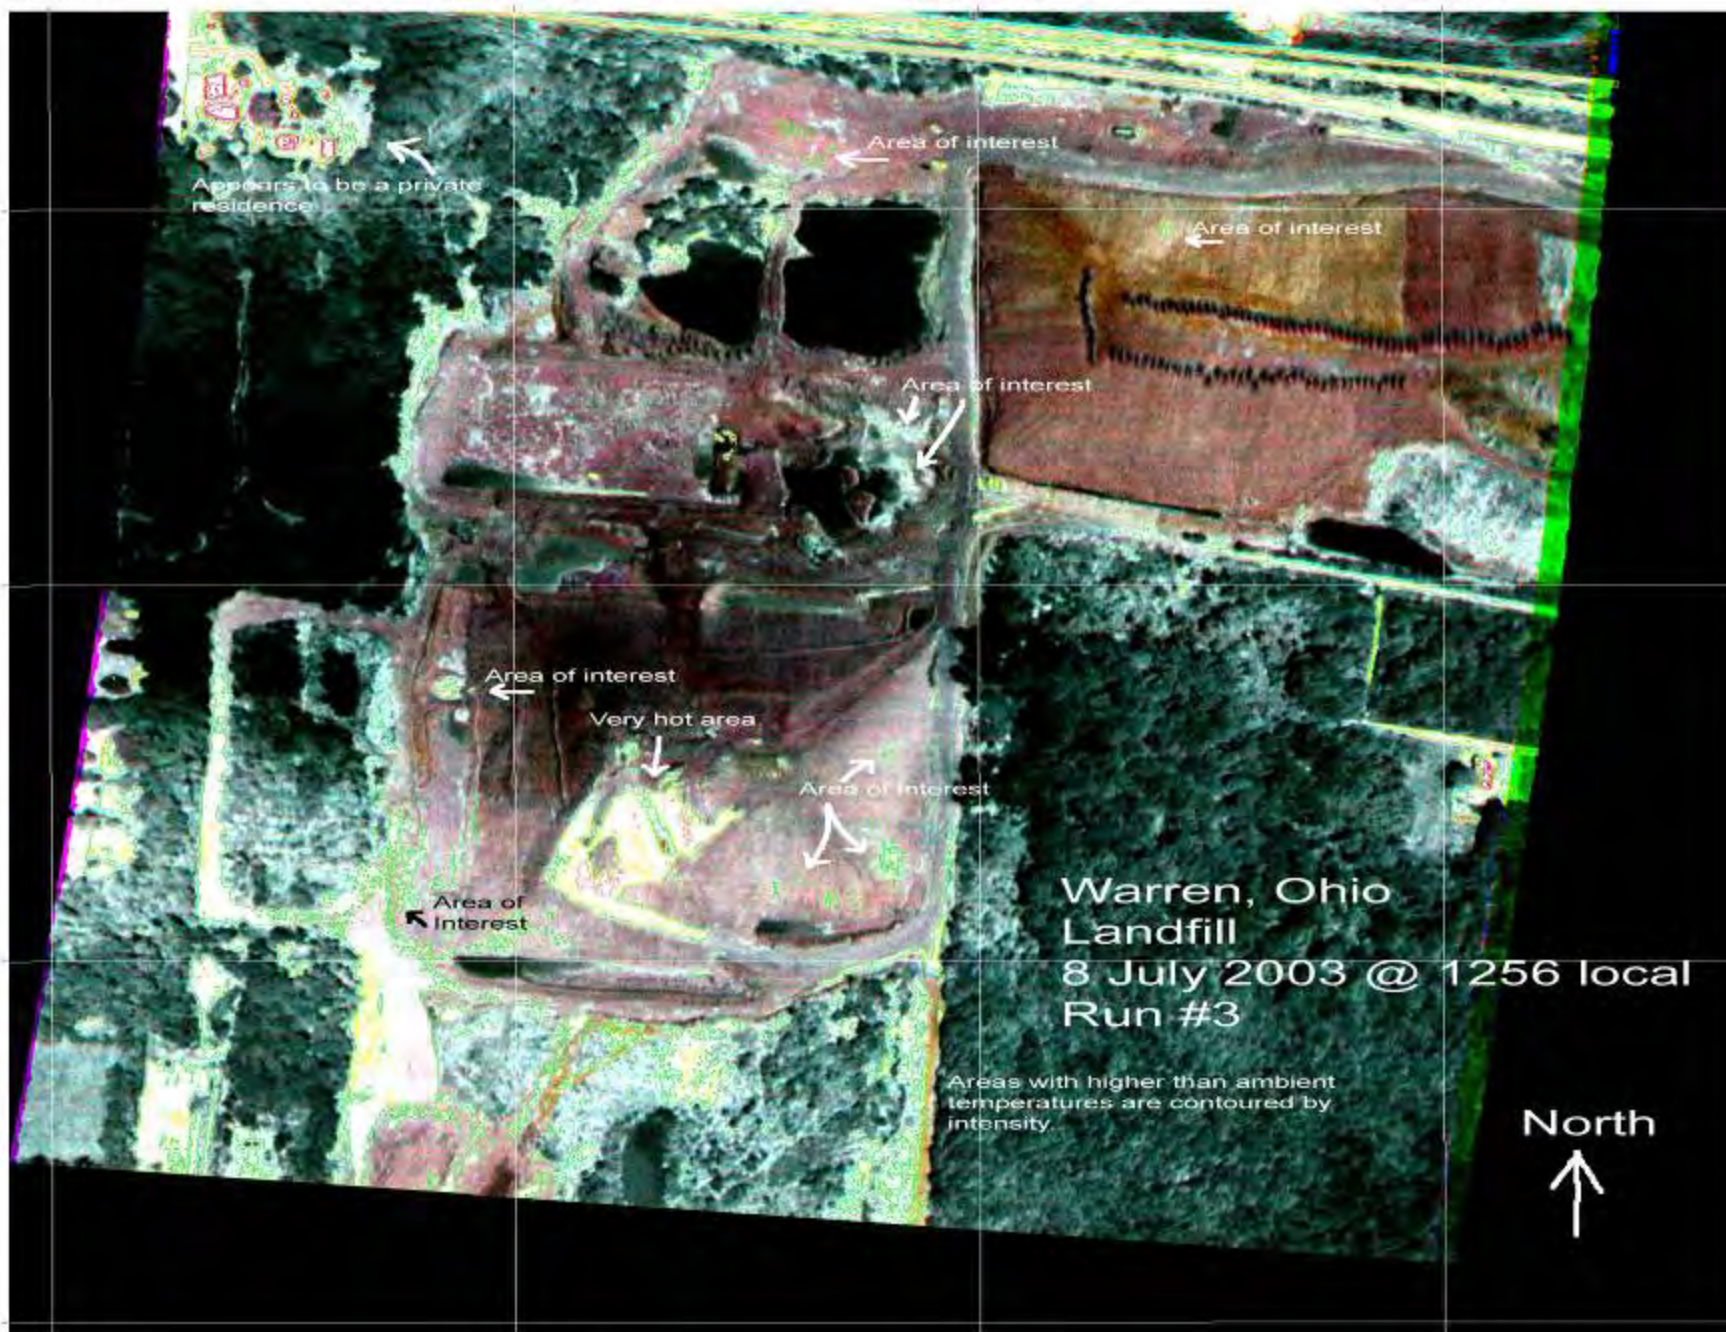
Warren, Ohio
Landfill
8 July 2003 @ 1256 local
Run #3

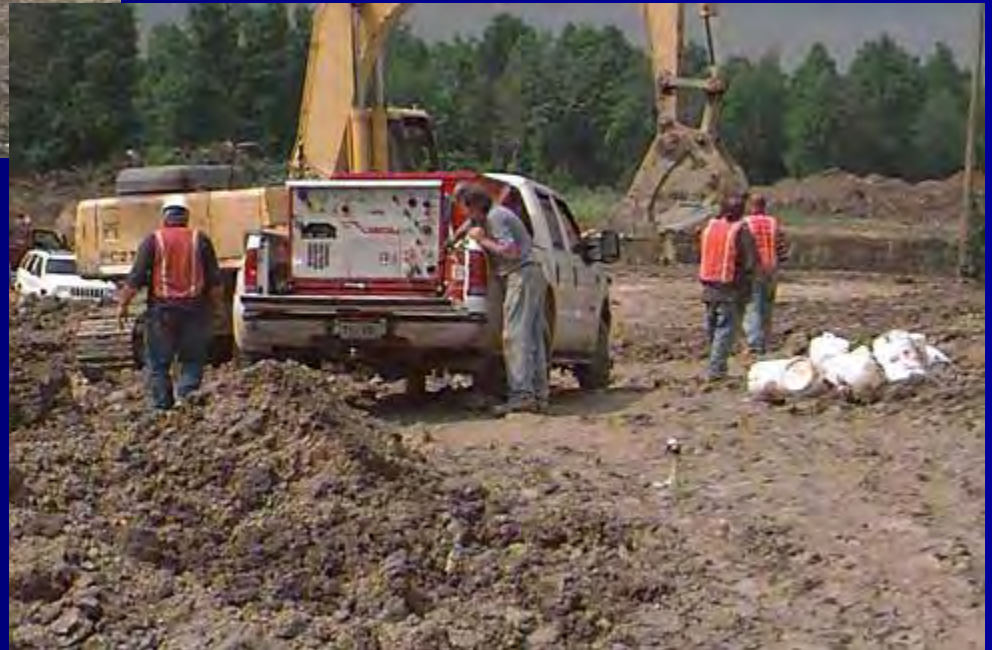
‘PyroCool’
